ESTATE SENTINEL

INSPECTION REPORT
NO. ES-2026-001

PROPERTY INSPECTION REPORT

PARQUE DEL ORIENTE · PUERTO RICO

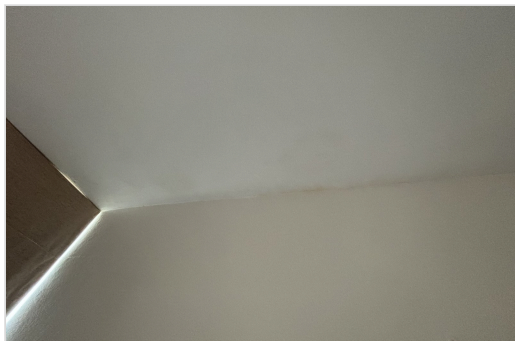
Moisture Intrusion at Interior Ceiling

A hairline crack at the ceiling–wall seam shows distinct yellow staining consistent with active moisture intrusion. Follow-up inspection on the roof above this area confirmed deficiencies in the roof sealant, identifying the likely source. While the staining is currently limited and there is no visible mold, untreated moisture intrusion in Puerto Rico’s climate typically progresses to ceiling damage and microbial growth within months.

(1) Roof sealant repair above the affected room. (2) After source is corrected and area is fully dry, complete cosmetic ceiling repair and repaint. (3) Re-inspect at next visit to confirm no recurrence.

Scope: (a) Sealant repair above affected interior room — Finding 01 source. (b) Inspect and address pooling area — Finding 02. (c) Clean and treat algae streaking on left-side exterior wall — Finding 04.

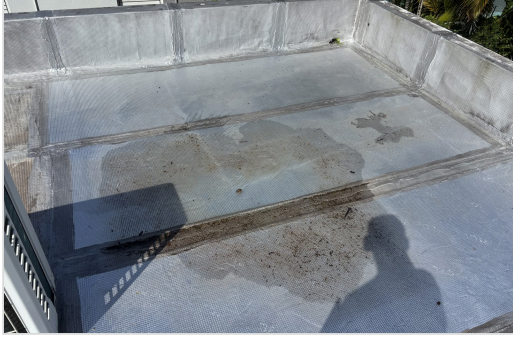
Standing Water on Flat Roof Section

Inspection of the flat roof revealed minor pooling and debris accumulation in a low spot of the fiberglass-mesh sealant surface. The area is currently sound, but standing water and trapped debris accelerate sealant wear over time and are a leading cause of future leaks. Documented as a baseline observation.

Clear loose debris during routine visits. Re-inspect at next walkthrough. If pooling persists or worsens, include in roof vendor scope along with Finding 01.

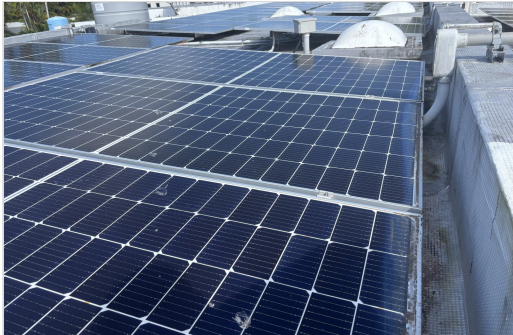
Solar Panel Soiling

The rooftop solar array shows visible bird droppings on multiple panels along with general dust and particulate buildup. Soiling reduces panel output and, when concentrated as droppings, can create localized hot-spotting that degrades cells over time.

Schedule professional solar panel cleaning. Consider establishing as a recurring maintenance item — typically every 4–6 months in Puerto Rico's environment.

Separate vendor (solar maintenance). Schedule cleaning of the rooftop array and consider establishing as a recurring maintenance item.

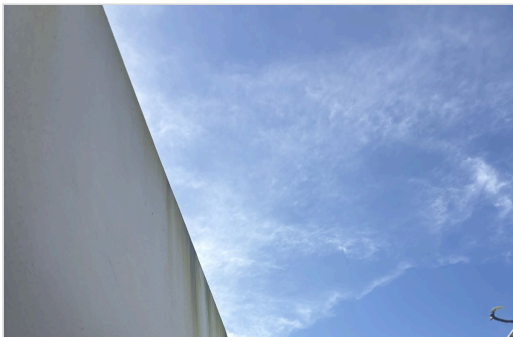
Algae Growth on Shaded Exterior Wall

Vertical green algae streaking is visible running down the left-side exterior wall from the parapet edge. Consistent with chronic moisture and limited sun exposure on that face of the property. Minor rust bleed is also visible at the base flashing line — an early indicator of coastal corrosion to watch.

Pressure wash and treat affected wall area. Repaint as needed. Inspect base flashing and address any active corrosion before it spreads.

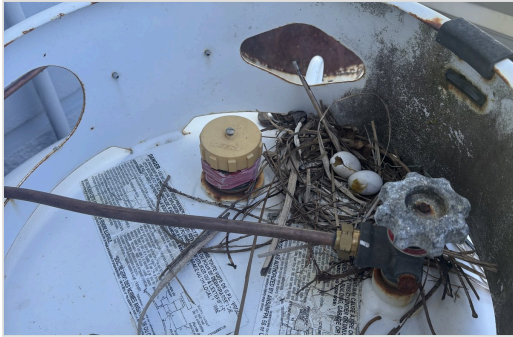
Bird Nest & Corrosion at Propane Tank Assembly

An active bird nest with eggs is sitting directly between the propane tank valves and regulator hardware. Dry nesting material is in contact with brass fittings and obstructs visual access to the gauge and shutoff. Surface corrosion is also visible on tank hardware. The generator itself is operating normally and fuel level is adequate.

- (1) Carefully remove nesting material — confirm wildlife considerations.
- (2) Inspect valves, regulator, and gauge for function.
- (3) Address surface corrosion; evaluate tank swap-out at next refill.

Estate Sentinel will coordinate cleanup of the bird nest and debris at the propane tank assembly with the appropriate landscaper or handyman and document completion. The corrosion and tank-condition assessment should be reviewed once the area is cleared. *No client action required unless hardware repair or tank swap-out is recommended after vendor review.*
